***Date:*** 4/01/2011

***Bulletin Number:*** 2011-04 T

**SUBJECT:** Sync Ignition Cable

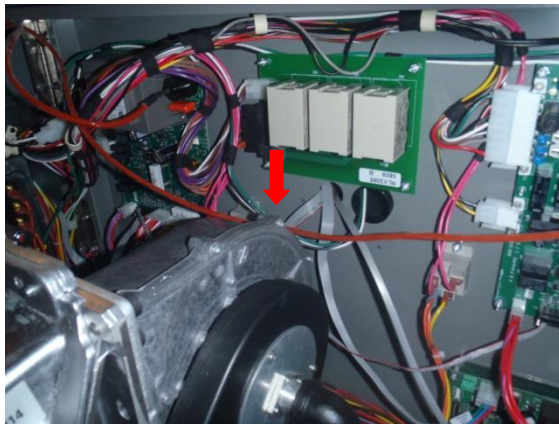
Fig 1

Lochinvar Corporation has determined that the location of the Sync ignition cable may create interference between the control modules. When the control panel door is closed the igniter cable for module one can slip between the fan housing and the control board panel (See figure 1). The cable resting near the fan housing can send a false electrical feedback through the cable causing a communication error to occur.
