## TECHNICAL SERVICE BULLETIN

*Bulletin Number:* 2005-06T

**SUBJECT:** Corrosion of Dissimilar Metals

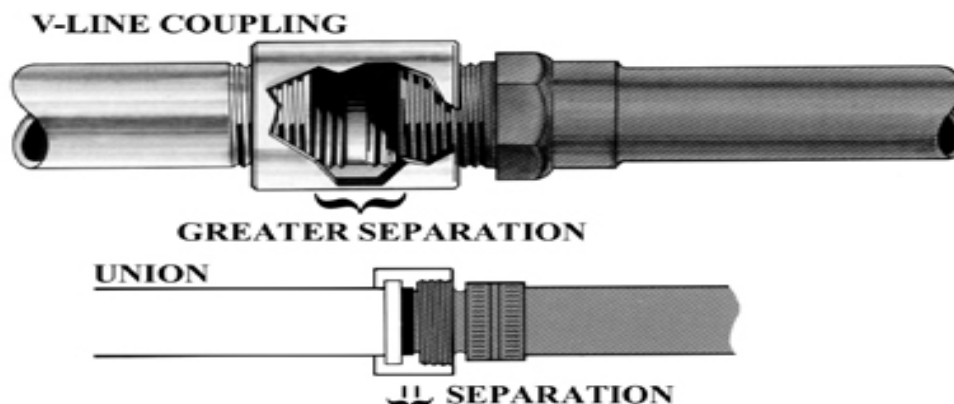
Field evaluations of installed Double Duty water heaters and other tank type models using this indirect internal coil have shown that there can be problems with electrolysis at the connection points. The electrolysis driven corrosion is due to the connection of the dissimilar metals (i.e., copper or steel) directly to the inlet and outlet connections. The resulting corrosion damage can eventually cause premature failure or leaks at the couplings, internal coil tube or nipples. This can be prevented by installing an insulating coupling or a dielectric union at all water connections to break the electrical flow due to the dissimilar metals.

When installing the insulating couplings or dielectric unions care should be taken to always use a back-up wrench or ford wrench to prevent turning or twisting of the tank fittings. Failure to use a back-up wrench may cause loosening of the tank connections or damage to the seal of the internal tank coil resulting in leakage.

The diagram below shows an example of the separation provided by proper installation of an insulating coupling or a dielectric union to help prevent dissimilar metal problems.
